Manhole Inspection Summary

Manhole # S19MM_011MH

Insp Date: **7/5/07 8:42 AM**

Location Address: **2224 MONROE ST**

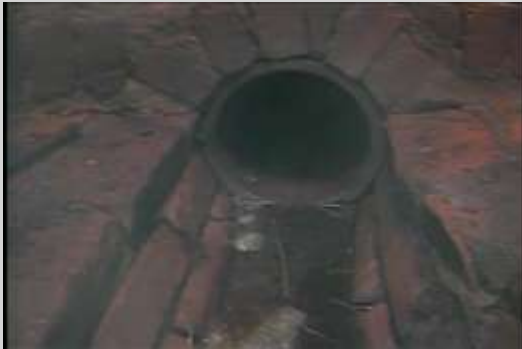
12 O'Clock Outflow

8 in. Circular Gravity Sewer
Pipe Out @ 12 O'Clock

Pipe Height: **8.4** (in.) Rod and Bar (Angled)
Pipe Material: **Clay** ☐ Pipe Lined
Invert Depth: **7.30** (ft.) Flow Characteristics: **None**
Deposits: ☒ None ☐ Mud ☐ Sludge ☐ Debris ☐ Grease
Silt Depth: (in.) Deposits Extent:
Infiltration: **None** Pipe Seal Cond: **Sound**

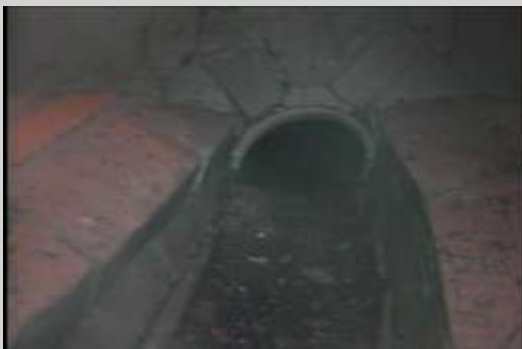
3 O'Clock Inflow

6 in. Circular Gravity Sewer
Pipe In @ 3 O'Clock

Pipe Height: **6** (in.) Rod and Bar (Angled)
Pipe Material: **Clay** ☐ Pipe Lined
Invert Depth: **7.21** (ft.) Flow Characteristics: **None**
Deposits: ☒ None ☐ Mud ☐ Sludge ☐ Debris ☐ Grease
Silt Depth: (in.) Deposits Extent:
Infiltration: **None** Pipe Seal Cond: **Sound**

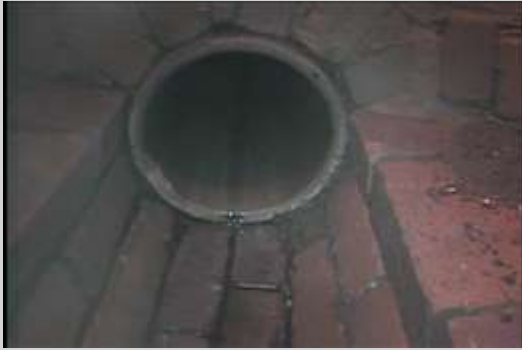
5 O'Clock Inflow

8 in. Circular Gravity Sewer

Pipe In @ 5 O'Clock

Pipe Height: **8.4** (in.) Rod and Bar (Angled)

Infiltration: **None** Pipe Seal Cond: **Sound**
